Demonstration and Validation of a High-Performance Floor-Sealant System to Reduce Concrete Degradation

Final Report on Project F10-AR02

Under Project F10-AR02, "Application of an Innovative, High Performance Concrete
Floor Sealant at Hunter Army Airfield, Georgia"

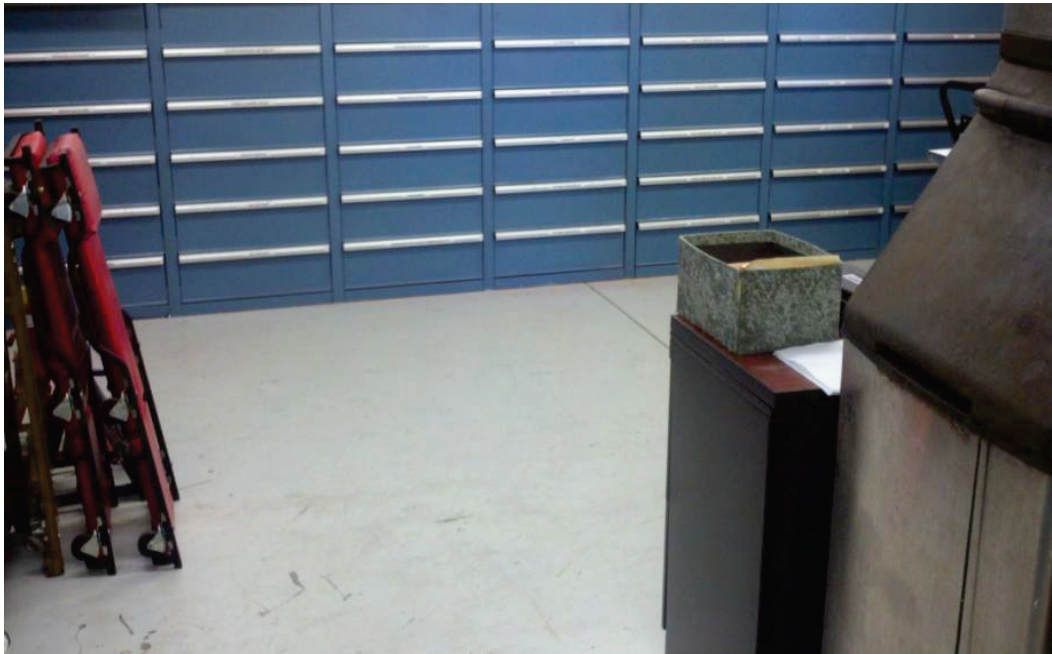
Figure 3. Tool room floor.

The previous paint on the maintenance bay floors was an epoxy-based coating that was deteriorating. The appearance of the floor was poor due to peeling, chipping, and staining. Because of the light color of the floor, frequent cleaning was necessary. In addition to the maintenance bays (Figure 1 and Figure 2), a tool room (Figure 3), office (Figure 4), training room (Figure 5), and hallways (Figure 6) were also included in this demonstration. The training room and hallways were covered with two layers of vinyl tile that had to be removed.
